DEPARTMENT OF TRANSPORTATION

Contract #: 04-0120F4Cty: SF/ALA Rte: 80 PM: 13.2/13.9File #: 99.28**WELDING INSPECTION REPORT****Resident Engineer:** Siegenthaler, Peter**Address:** 333 Burma Road**City:** Oakland, CA 94607**Report No:** WIR-019300**Date Inspected:** 17-Jan-2011**Project Name:** SAS Superstructure**OSM Arrival Time:** 700**Prime Contractor:** American Bridge/Fluor Enterprises, a JV**OSM Departure Time:** 1900**Contractor:** Zhenhua Port Machinery Company, Ltd (ZPMC)**Location:** Shanghai, China**CWI Name:** Li Yang and Zhu Zhong Hai**CWI Present:** Yes No**Inspected CWI report:** Yes No N/A**Rod Oven in Use:** Yes No N/A**Electrode to specification:** Yes No N/A**Weld Procedures Followed:** Yes No N/A**Qualified Welders:** Yes No N/A**Verified Joint Fit-up:** Yes No N/A**Approved Drawings:** Yes No N/A**Approved WPS:** Yes No N/A**Delayed / Cancelled:** Yes No N/A**Bridge No:** 34-0006**Component:** OBG Trial Assembly**Summary of Items Observed:**

WELDING INSPECTION REPORT

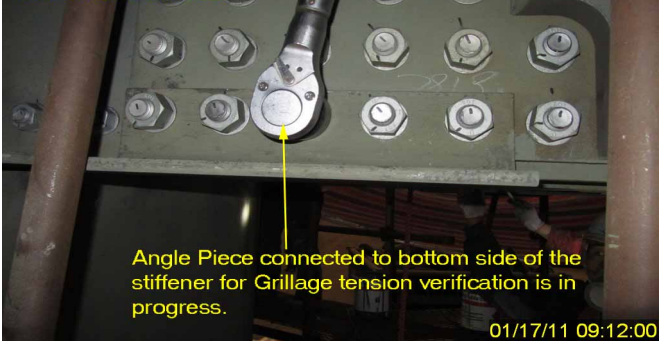
Tower Lift 5 (Grillage) at Bay # 11, bolts connecting the Angle piece of Tower Grillage North, South, East and West to the Transverse and Longitudinal Stiffeners at the Bottom Face and bolts tension verified.

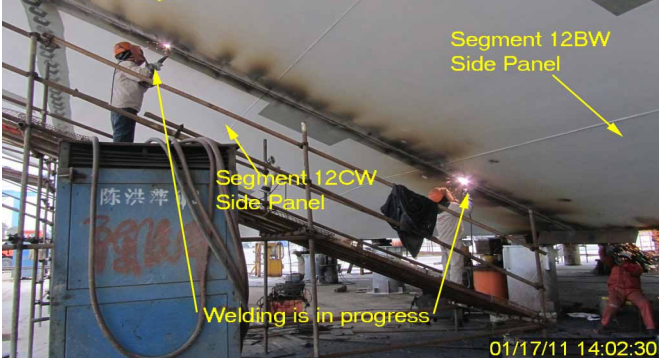
Segment 12BW to Segment 12CW, Side Panel Transverse splice welding is in progress, Counter Weight side at OBG Trial Assembly.

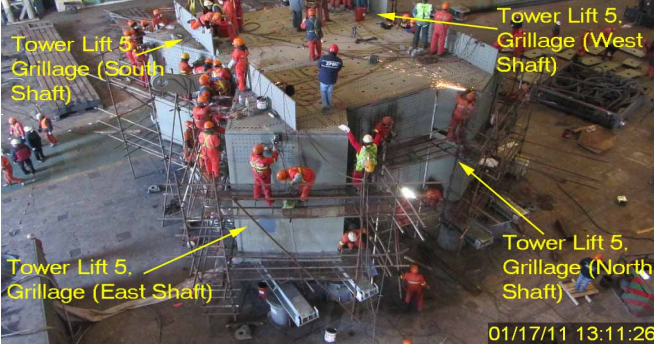
Tower Lift 5 (Grillage) at Bay # 11, bolts connecting the Angle Piece of Tower Grillage North to the Transverse and Longitudinal Stiffeners at the Bottom Face tension verification verified.

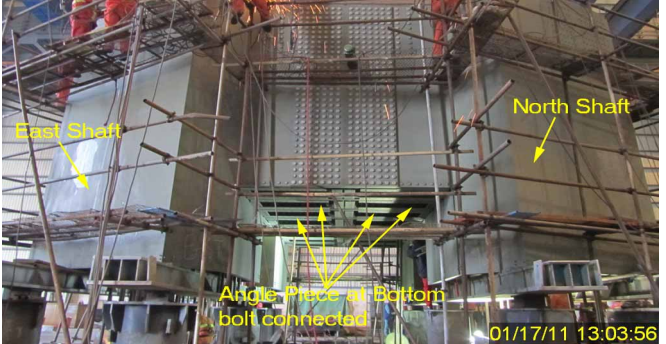
Tower Lift 5 (Grillage) at Bay # 11, bolts connecting the Angle Piece of Tower Grillage North to the Transverse and Longitudinal Stiffeners at the Bottom Face tension verification verified.
